Resolution Accepting the Finding of Necessity Study for the Goulds/Cutler Ridge

Area and approving the preparation of a Community Redevelopment Plan

This Finding of Necessity (FON) report assesses conditions of slum and blight in the Goulds area in order to determine if the formation of a Community Redevelopment Area and a Community Redevelopment Agency are appropriate.

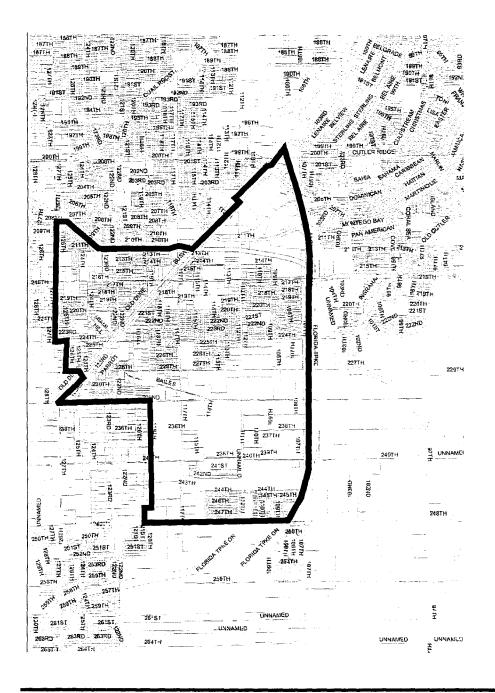
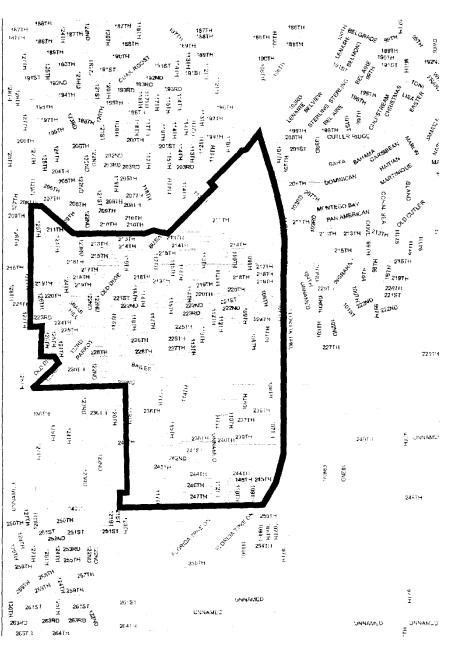
In summary, 88 of the 3,291 residential buildings are showing signs of deterioration, and 11 are dilapidated. Together, the deteriorating and dilapidated buildings are 5% of the stock of residential structures in this area. On a typical block of 16 to 20 lots, this would mean that approximately one building is deteriorated or dilapidated; however, these conditions are not evenly distributed throughout the area. The heaviest concentration of deteriorated and dilapidated structures is in the section south of old Cutler Road (SW 220th St.) to SW 224th Street, and west of SW 114th Avenue. The second highest concentration of poor physical conditions is in the West Goulds sub-area, in the section east of SW 122nd Avenue and north of SW 220th Street. Examples of the quality and condition of the residential properties are shown in Figures 4A and 4B, Residential Site Photographs.

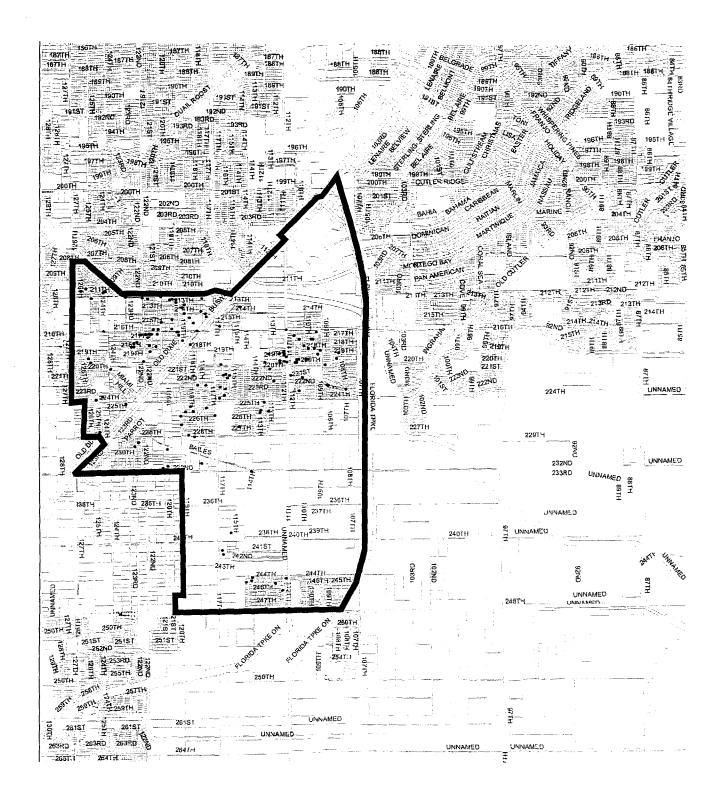
Legend Figure 5
Open Code Violation Map
Goulds / Cutler Ridge CRA

To further support the visual survey, data was gathered from Miami-Dade County with respect to code violations. **Table 4, Open Code Violations**, lists the open code violation cases and **Figure 5, Open Code Violations** shows the extent of the code violations throughout the study area. Details of the open code violations are contained in **Appendix A**.

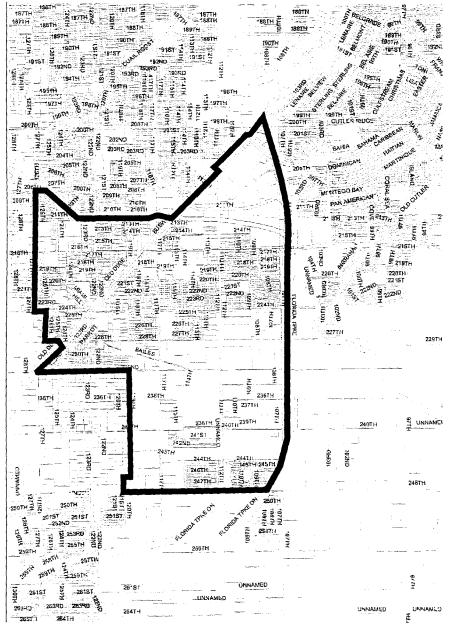
Figure 8 Trash Site Photographs Goulds / Cutler Ridge CRA

Vacant lots diminish a community's value because they attract dumping, and are usually overgrown. The dumping and trash, in combination with overgrown tall grasses can easily create a higher risk of fire hazard, as well as attracting vermin that create other health risks. Finally, vacancies under these conditions may contribute to higher crime due to their provision of large spaces that are hidden from view and not easily patrolled by police. Examples of the trash and dumping that vacant lots attract are illustrated in **Figure 8**, **Trash Site Photographs**.

There are 981 vacant residential parcels out of 3,320 according to Property Appraiser data that are within the proposed Goulds CRA. Based on the physical conditions survey, approximately 20% to 30% of these have some amount of trash, and dumping upon them. As this can compromise general public health, safety, and endanger adjacent properties by fire or propagation of insects, these conditions are a contributing factor to blight.

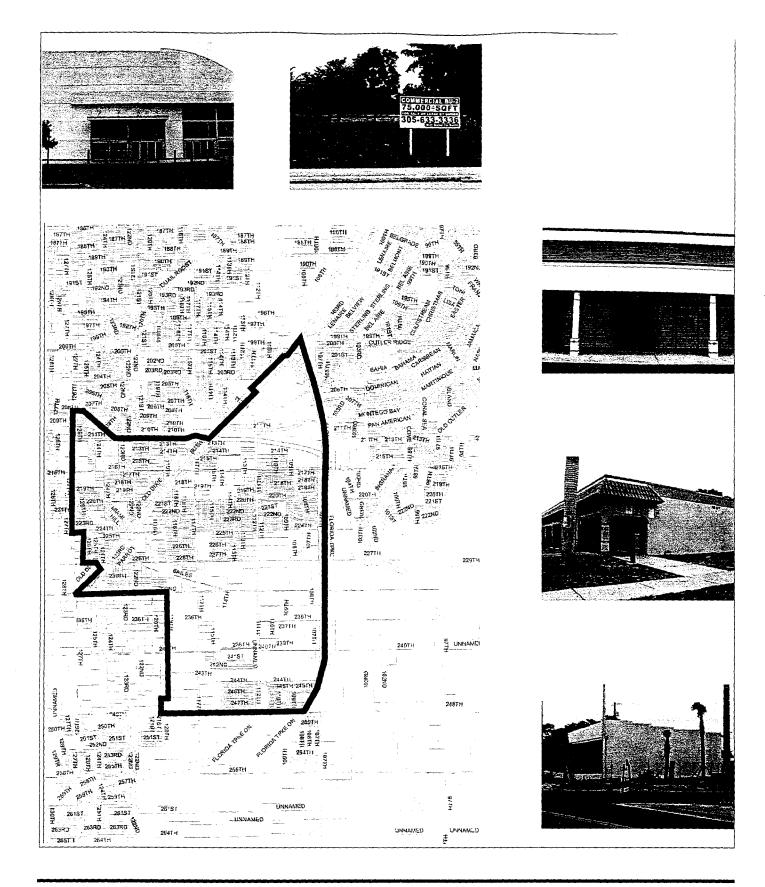
Figure 10 Vacant Retail Photographs Goulds / Cutler Ridge CRA

- The presence of large institutional facilities such as the South Dade Government Center and public housing units that are tax-exempt.
 - Vacant retail uses scattered throughout the study area as illustrated in Figure 10, Vacant Retail Photographs.

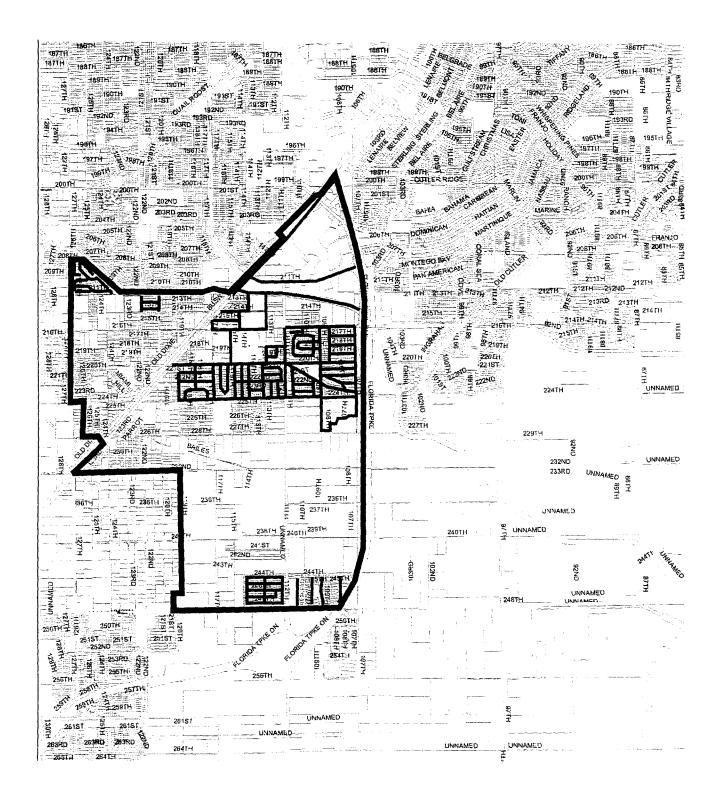
Legend		Figure 13
Sidewalks on both sides of street	Property boundary	Sidewalk Locations
Sidewalks on one side of street		Goulds / Cutler Ridge CRA
\triangle

The older and unimproved sections of the CRA study area have been found to exist with incomplete pedestrian infrastructure (see Figure 13), which impacts the provision of services and facilities used to support public transportation. Approximately 78% of the study area has no pedestrian infrastructure, while over 60% of the land area located within the CRA boundaries is located within one mile of the Busway corridor. The remaining land area is located within one mile of Bus Route 70, traveling north and south along SW 112 Avenue (see Figure 14). Three Miami-Dade County transit routes (plus the busway) operate along US-1 and serve the Southland employment center in the northern end of the CRA study area. A fourth transit route also serves the employment center, but provides access to the Cities of Homestead and Florida City using the SW 112 Avenue corridor. Service frequency headways throughout the CRA study area range from 15 minutes to 30 minutes. Considering that the entire CRA study area is located within a mile from a transit corridor, and given the extension of the busway which is currently under construction adjacent to the CRA along US-1, an extensive and continuous network of pedestrian facilities should exist to reinforce connectivity with the transit service along US-1. The existence of intermittent sidewalks within the CRA boundaries contributes to the inadequacies of the street layout and the deficiencies which exist in the provision of pedestrian infrastructure.

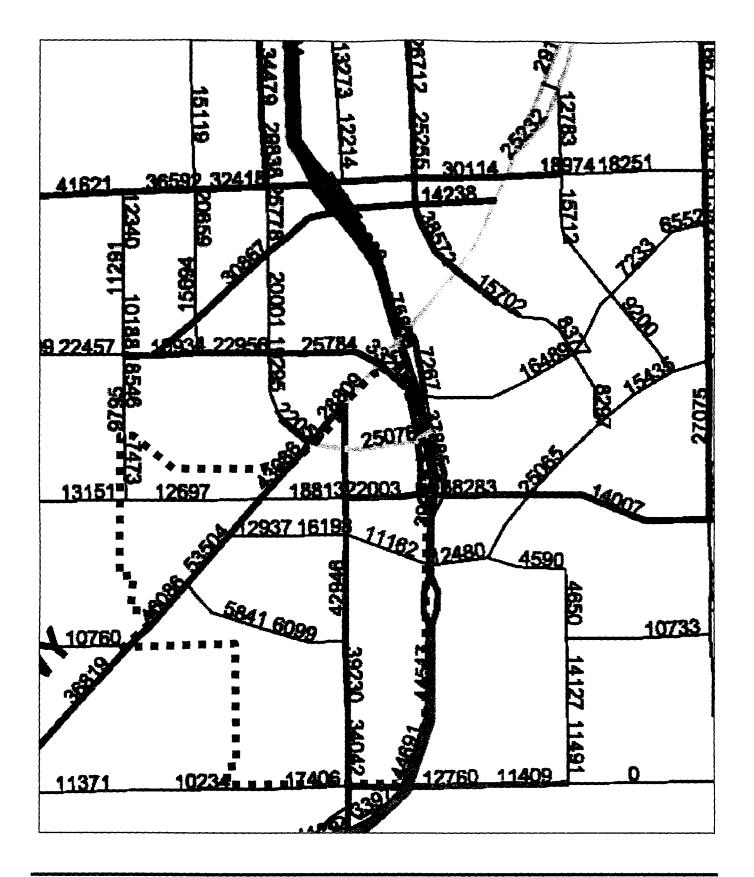
Figure 15 Year 2025 Traffic Forecasts Goulds CRA

XXXXX Year 2025 Projected Traffic Volumes
